BEHAVIOR OF DAMAGED GRAPHITE/EPOXY LAMINATES
UNDER COMPRESSION LOADING

Boeing Commercial Airplane Company
Seattle, Washington

NASA Contractor Report 159293

FINAL REPORT

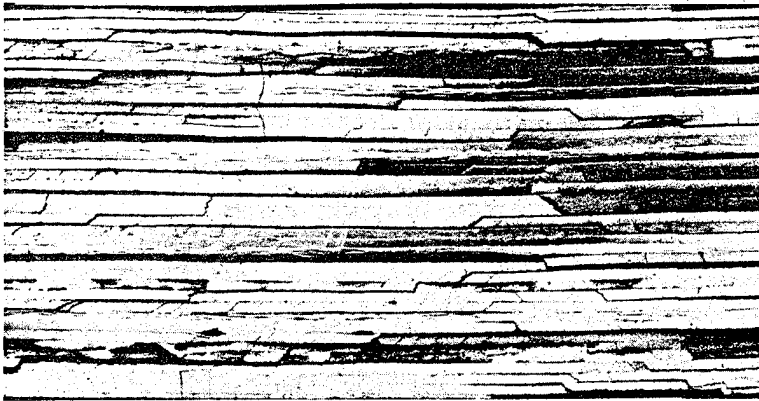
Figure 11. Comparison of Fracture Modes Following Low-Velocity Impact

- T300/5208
 - Impact = 15.8J (140 in-lb)
 - Delamination
 - Transverse cracks
 - Internally shattered

- T300/BP907
 - Impact = 31.6J (280 in-lb)
 - Delamination
 - Fiber fracture
 - Transverse cracks

- T300/P1700
 - Impact = 15.8J (140 in-lb)
 - No damage under impactor
 - Transverse cracks

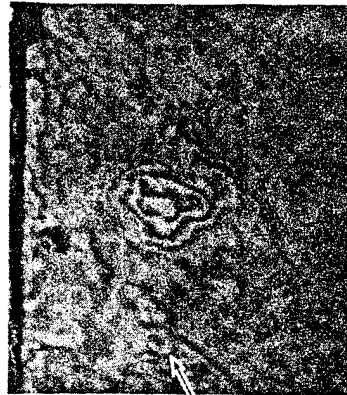
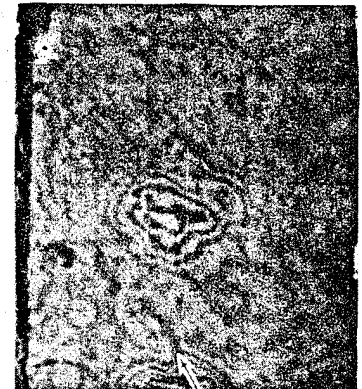
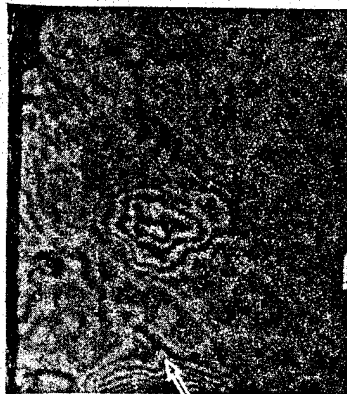
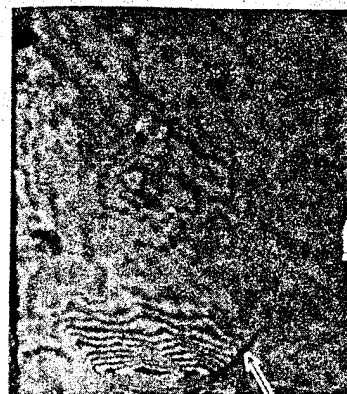
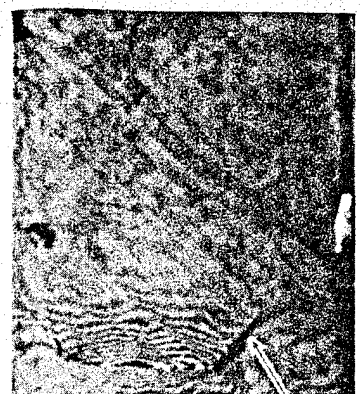
N = 1000*
Initial delamination
3.81-cm (1.5-in)
diameter, 4 plies deep

N = 13 000*
New damage
nucleation

N = 15 000*
Damage growth

N = 19 000*
Damage growth

N = 26 000*
Delamination growth
plus cracking

N = 28 000*
Appearance close to
failure

*Strain range = -6000 to -600 $\mu\text{cm}/\text{cm}$

During an attempt to monitor delamination growth in a T300/BP907 specimen with the same simulated delamination size and position, an interesting feature developed. Figure 28 is a series of moiré fringe photographs for this specimen. At the cyclic compression strain level of -6500 to -650 $\mu\text{cm/cm}$, the region over the delamination buckles on every cycle; however, with an increasing number of cycles, delamination growth initiates in a region away from the specimen edges and initial delamination position. NDI scans prior to testing gave no indication of damage at this location. This behavior was atypical of the simulated delamination cyclic compression tests. Cyclic compression lives for all the simulated delamination tests are summarized in Table 11.
